NATIONAL TRANSPORTATION SAFETY BOARD
Vehicle Recorder Division
Washington, D.C. 20594

Flight Data Recorder - 10

Group Chairman's Factual Report
By Sarah McComb

Location:	Lexington, Kentucky
Date:	August 27, 2006
Aircraft:	Canadair CL-600-2B19 (CRJ-100), N431CA
Operator:	Comair, Flight 5191
NTSB Number:	DCA06MA064

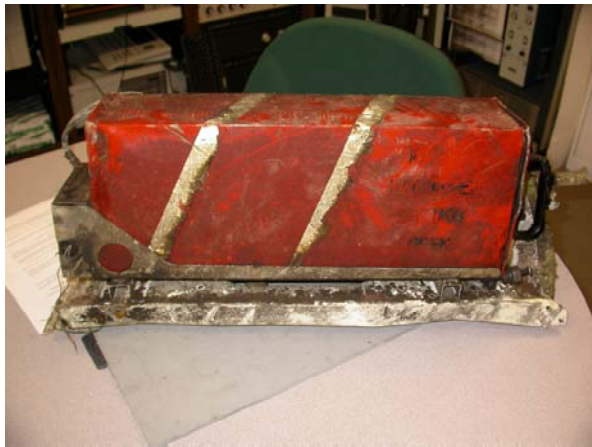
Figure 1: External View of FDR

The recorder displayed evidence of external damage due to fire (Figure 1). The internal components were in good condition (Figure 2) and the data were extracted normally from the recorder.
